# Manhole Inspection Summary

Manhole # S690\_\_013MH

Insp Date: **4/17/08 9:31 AM**

**Location** Address: **1313 Dundalk Ave.**

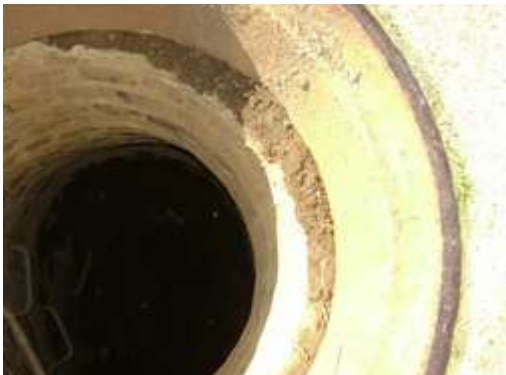
Defect 1

Offset: **2** (in.)

☒ **Leaks**

frame offset with infiltration evidence

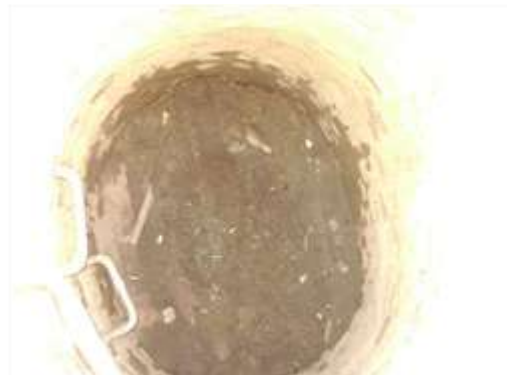
Defect 2

Condition: ☐ Sound ☐ Cracked ☐ Root Intrusion ☐ Loose Brick ☒ **Deteriorated**

Infiltration: ☐ None ☐ Joint ☐ Cracks ☒ **Mortar** ☐ Roots ☒ **Wall**

Condition: ☐ Sound ☐ Cracked ☐ Root Intrusion ☐ Deteriorated ☐ Leaks ☒ **Debris**

debris on bench/channel, infiltration on barrel walls through mortar

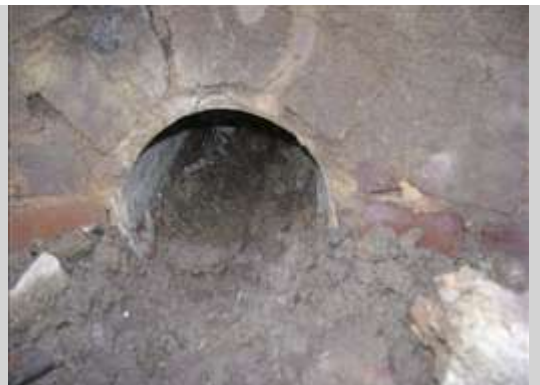
12 O'Clock Outflow

8 in. Circular Gravity Sewer  
Pipe Out @ 12 O'Clock

Deposits: ☐ None ☒ **Mud** ☐ Sludge ☒ **Debris** ☐ Grease

Silt Depth: **2** (in.) Deposits Extent: **Medium**
